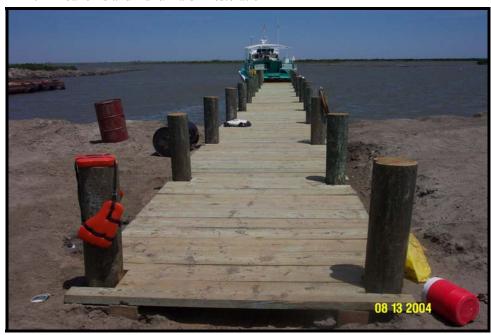
Photo 1. View of constructed dock (appx. Sta. 170+00) at end of access canal, looking north

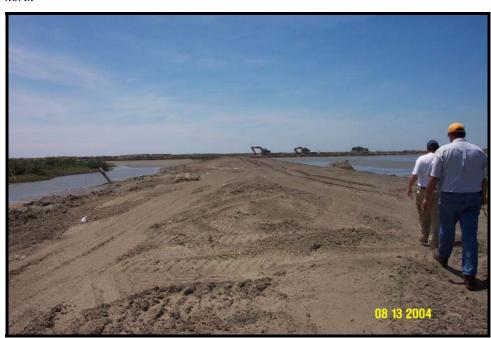
Photo 2. View of access berm at appx. Sta. 170+00, looking south

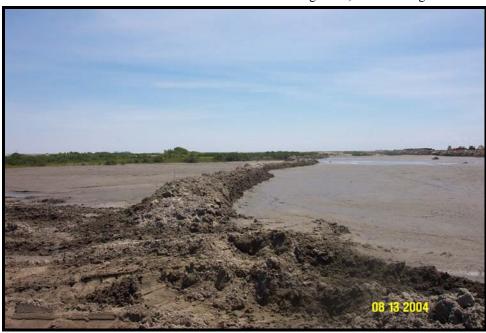
Photo 3. View of 100' back berm (right side) and back barrier marsh platform (left side), standing at appx. Sta. 170+00 looking east

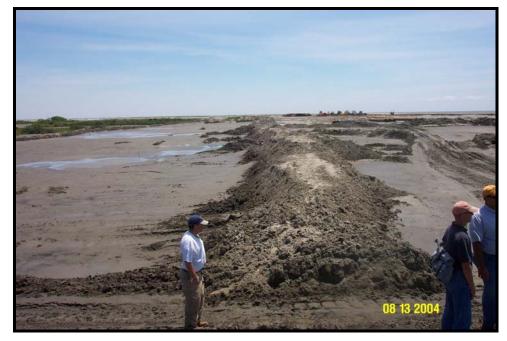
Photo 4. View of dune back dike, dune platform (right side), and 100' back berm (left side), standing at appx. Sta. 170+00 looking east

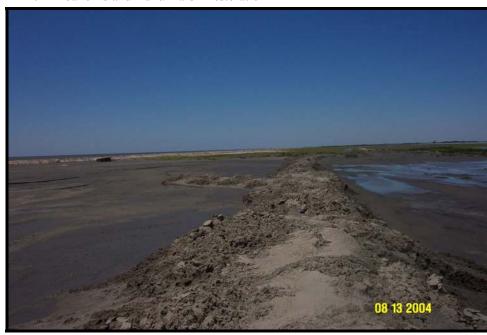
Photo 5. View of dune back dike, dune platform (left side), and 100' back berm (right side), standing at appx. Sta. 170+00 looking west

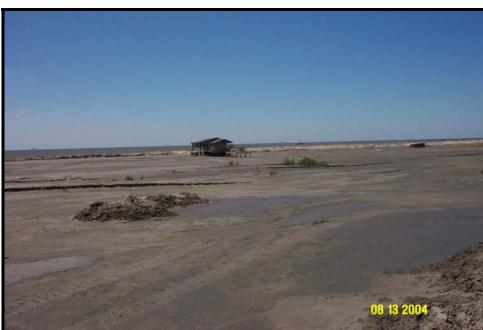
Photo 6. View of camp (appx. Sta. 167+00) and dune platform (~EL. 6.0), standing on dune back dike at appx. Sta. 170+00 looking southwest

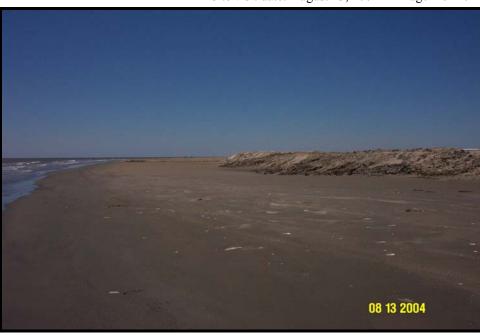
Photo 7. View of beach fill and east end of dune platform (Sta. 206+00), looking west

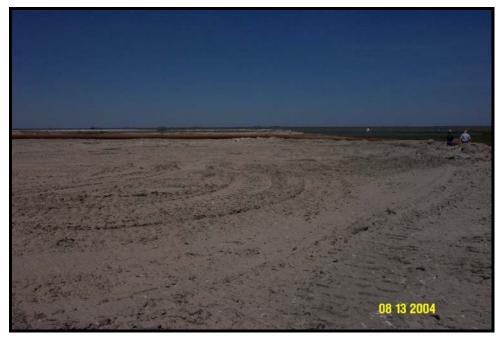
Photo 8. View of constructed dune platform (EL. 8.0) at east end of project (Sta. 206+00), standing on Gulf side dike looking north

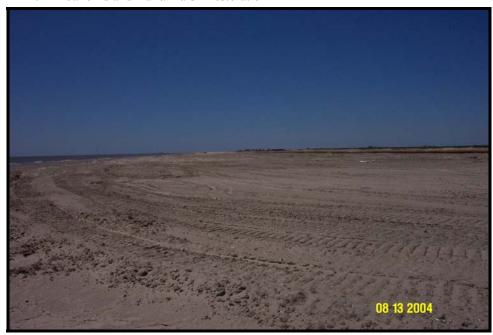
Photo 9. View of constructed dune platform (EL. 8.0), standing on dune at east end of project (Sta. 206+00) looking west

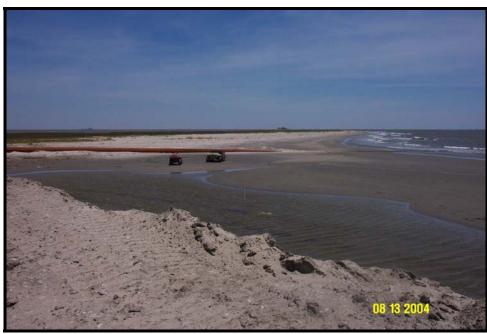
Photo 10. View of discharge pipe and beach beyond east end of project, standing on dune at end of project (Sta. 206+00) looking east

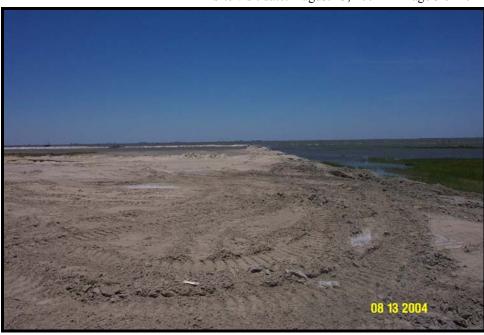
Photo 11. View of dune platform (EL. 8.0), back berm, and marsh platform, standing on dune platform at east end of project (Sta. 206+00) looking north

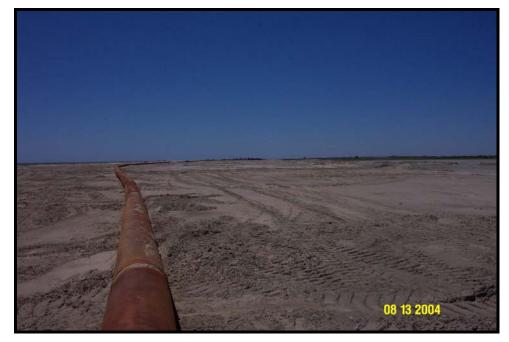
Photo 12. View of constructed dune platform (EL. 8.0), standing on dune at east end of project (Sta. 206+00) looking west

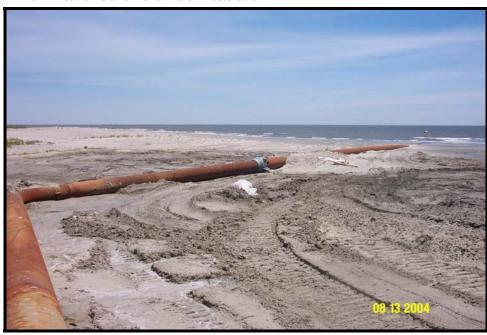
Photo 13. View of discharge pipe at east end of project, looking southeast

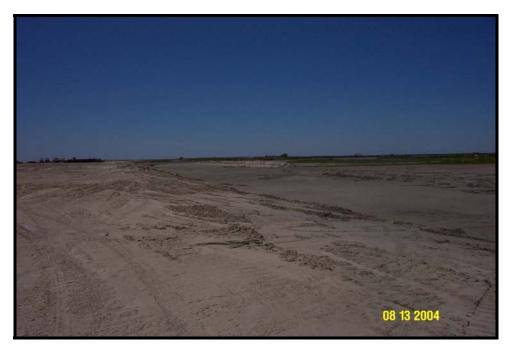
Photo 14. . View of dune platform, back berm, and marsh platform, standing on dune platform at appx. Sta. 190+00 looking west

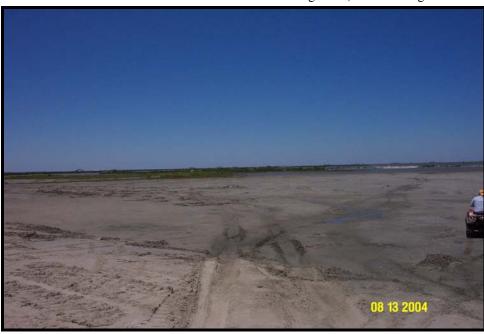
Photo 15. View of marsh platform, standing on dune platform at appx. Sta. 190+00 looking northwest

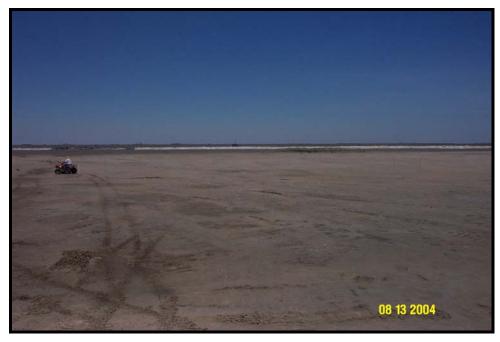
Photo 16. View of marsh platform, standing on dune platform at appx. Sta. 190+00 looking north

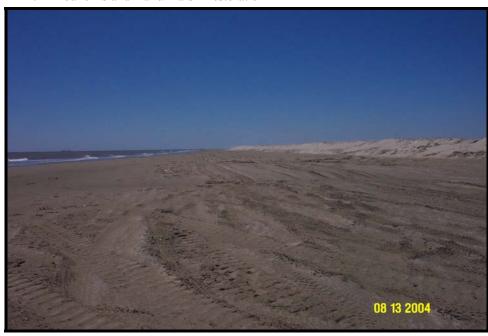
Photo 17. View of beach fill and Gulf side dike, standing on beach at appx. Sta. 190+00 looking west

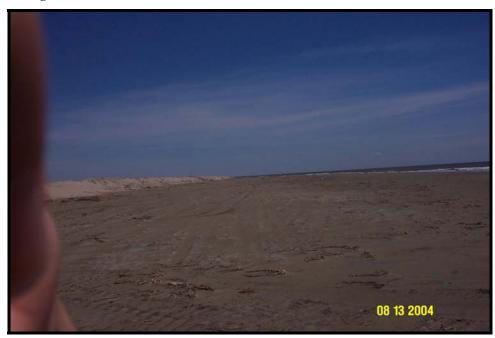
Photo 18. View of beach fill and Gulf side dike, standing on beach at appx. Sta. 190+00 looking east

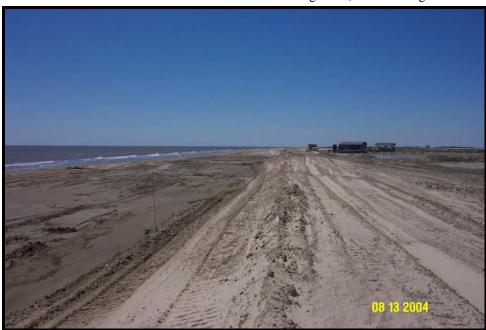
Photo 19. View of beach fill (left side) and dune platform (right side), standing on top of dike at appx. Sta. 173+00 looking west

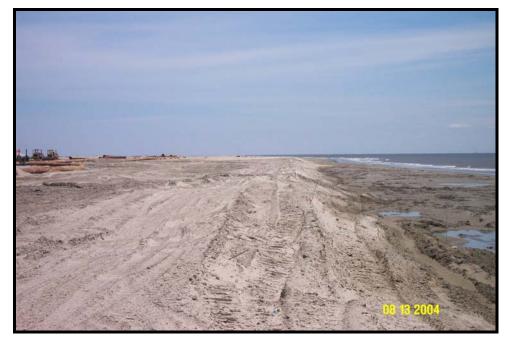
Photo 20. View of beach fill (right side) and dune platform (left side), standing on top of dike at appx. Sta. 173+00 looking east

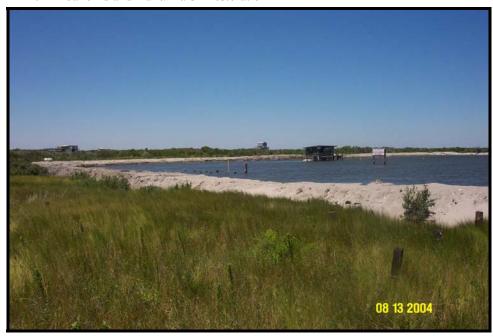
Photo 21. View of front and side dikes at west end of project at the end of Canal 19, standing Gulf side of project at appx. Sta. 95+00 looking northwest

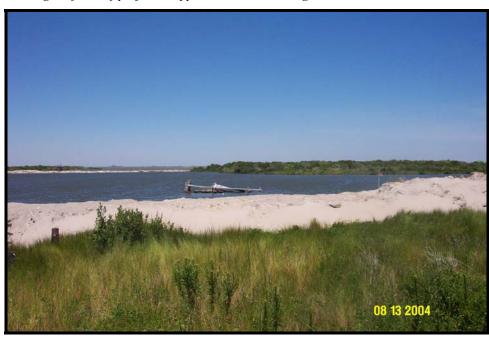
Photo 22. View of front and back dikes at west end of project at the end of Canal 19, standing Gulf side of project at appx. Sta. 95+00 looking north

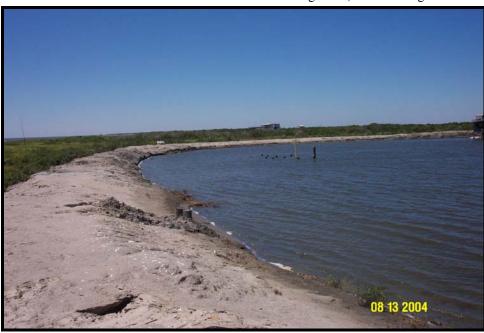
Photo 23. View of front and side dikes at west end of project at the end of Canal 19, standing on top of front dike at appx. Sta. 95+00 looking west

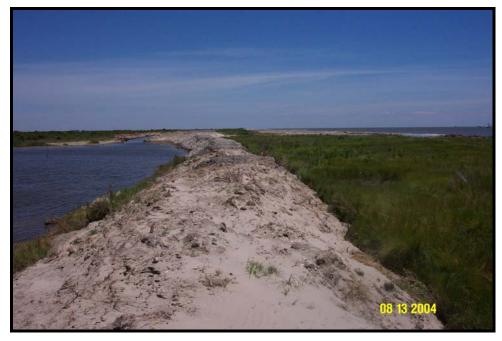
Photo 24. View of front dike at west end of project at the end of Canal 19, standing on top of dike at appx. Sta. 95+00 looking east

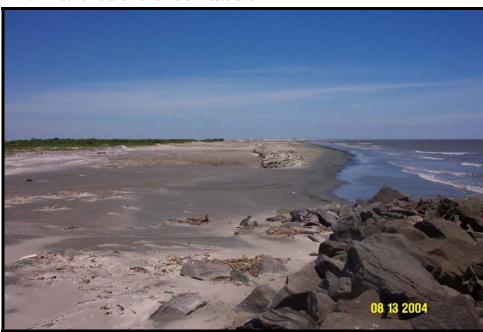
Photo 25. View of beach fill, standing on top of existing rock shoreline protection at appx. Sta. 100+00 looking east

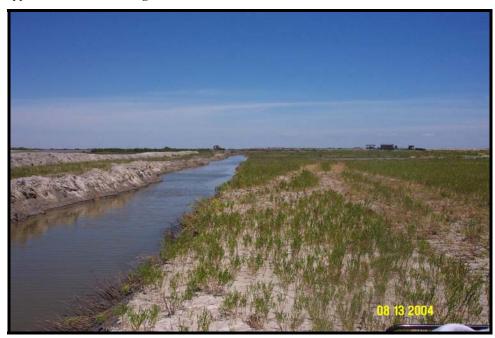
Photo 26. View of dune platform back dike, standing inside dune platform area at appx. Sta. 160+00 looking east

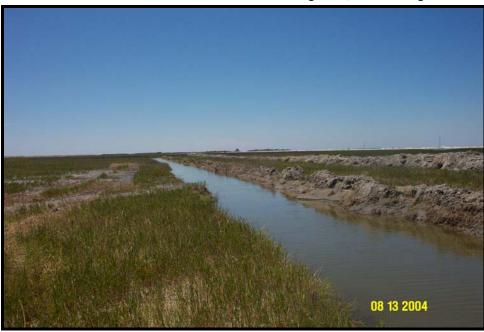
Photo 27. View of dune platform back dike, standing inside dune platform area at appx. Sta. 160+00 looking west

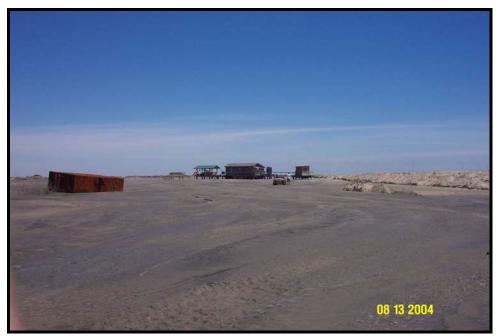
Photo 28. View of dune platform (material to ~EL. 6.0), standing on top of dune material at appx. Sta. 164+00 looking east

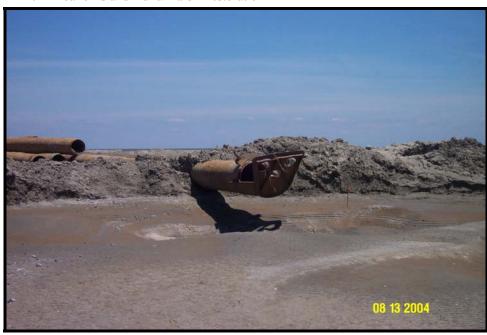
Photo 29. View of end of dredged material discharge pipe at appx. Sta. 171+00 (dredge demobilized due to storms in Gulf)

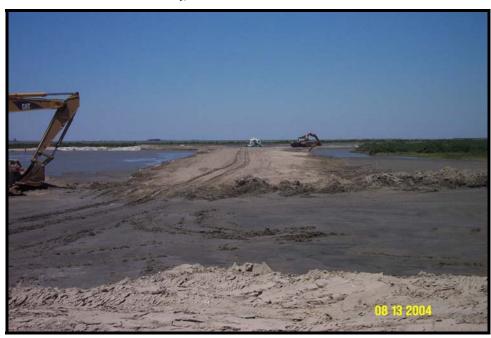
Photo 30. View of access berm (appx. Sta. 170+00), standing on top of dune back dike looking north

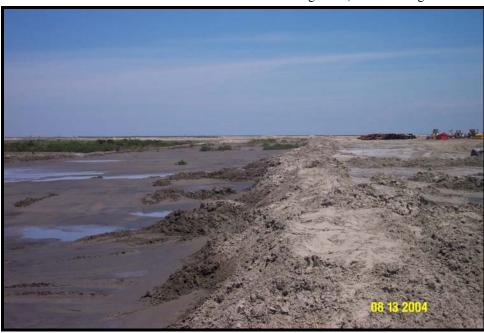
Photo 31. View of dune back dike, dune platform material (right side), and 100' back berm (left side), standing at appx. Sta. 171+00 looking east

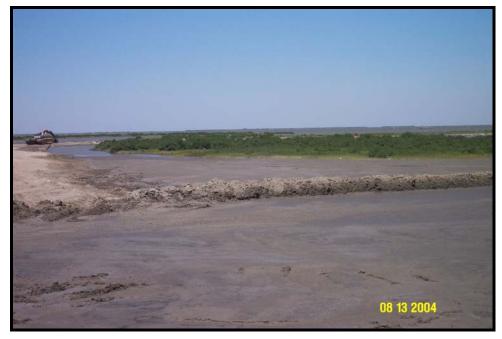
Photo 32. View of 100' back berm (foreground) and back barrier marsh platform (background) on east side of access berm, standing at appx. Sta. 171+00 looking north

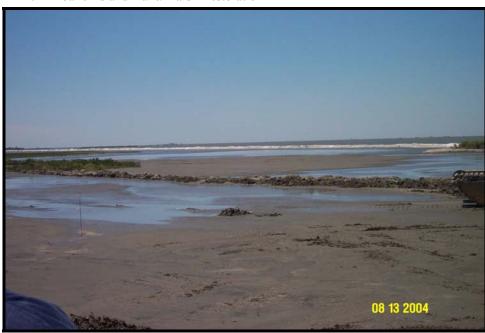
Photo 33. View of 100' back berm (foreground) and back marsh platform (background) on west side of access berm, standing at appx. Sta. 170+00 looking northwest

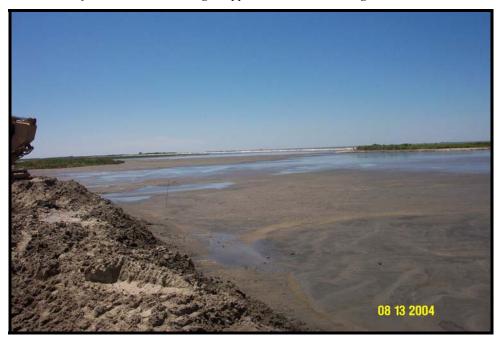
Photo 34. View of back marsh platform area on west side of access berm, standing at appx. Sta. 170+00 looking northwest

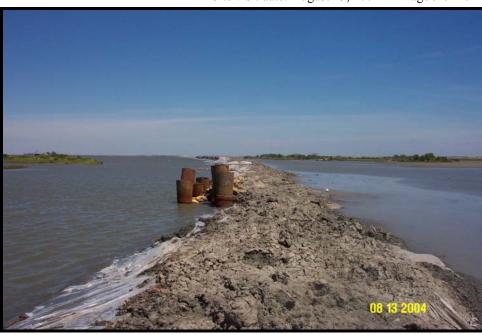
Photo 35. View of breach repair in back dike at appx. Sta. 178+00, looking east

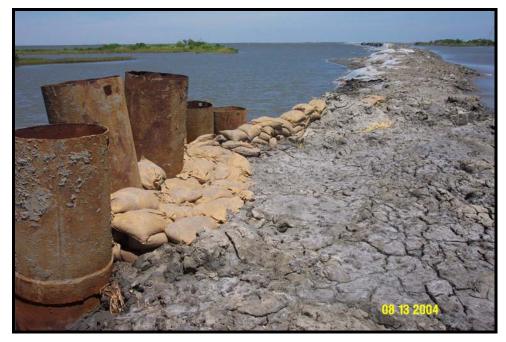
Photo 36. View of breach repair in back dike at appx. Sta. 178+00, looking east

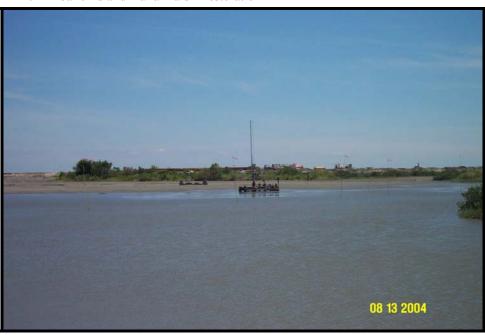
Photo 37. View of back barrier marsh platform, standing on back dike at appx. Sta. 177+00 looking south

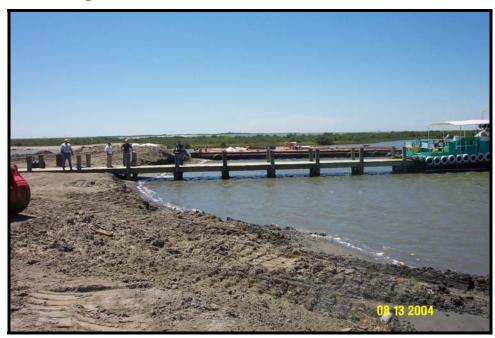
Photo 38. View of constructed dock (appx. Sta. 170+00) at end of access canal, looking west
